**Flood Control Project Maintenance
Levee Inspections**

Maintenance Issue Types Only, Levee Inspection Report By Mile - Fall 2015

Merced Streams Group

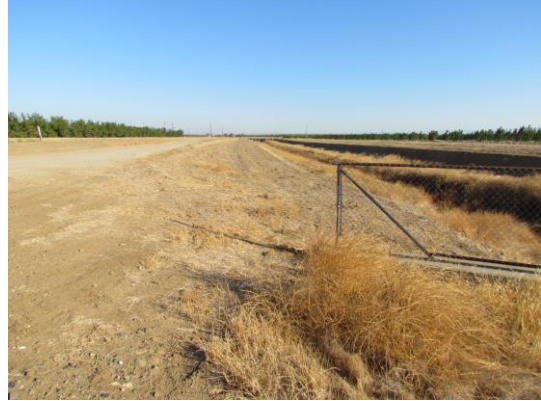
Photo 1 of 1 : FA_2015_NA0013_331_1_20151020_00001.jpg

LM Start	0.00	Rating **	A	Issue No.	1
LM End	0.32	Issue Type +	Ma	Location *	WS
Category	Earthen Levee			GPS Latitude/Longitude	
				Start	End
Item	Vegetation			37.314698 °	37.319278 °
				-120.396397 °	-120.396582 °
DWR ID	DWR_NA0013_01_f _ 2015_1				
Action/Comments					
Control annual grass and weeds on the levee slopes and easements. Inspector Comments: No unwanted vegetation on the levee slopes.

Black Rascal Creek looking downstream from levee mile 0.00 waterside slope.

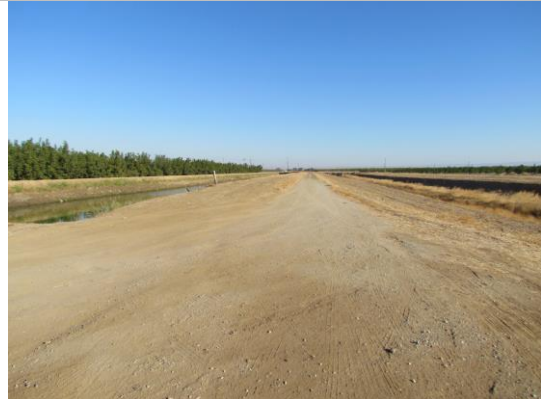
Photo 1 of 1 : FA_2015_NA0013_331_2_20151020_00002.jpg

LM Start	0.00	Rating **	A	Issue No.	2
LM End	0.51	Issue Type +	Ma	Location *	LS
Category	Earthen Levee			GPS Latitude/Longitude	
				Start	End
Item	Vegetation			37.314698 °	37.321980 °
				-120.396397 °	-120.396588 °
DWR ID	DWR_NA0013_01_f_2015_2				
Action/Comments					
Control annual grass and weeds on the levee slopes and easements. Inspector Comments: No unwanted vegetation on the landside slope.

Black Rascal Creek looking downstream from the landside levee slope.

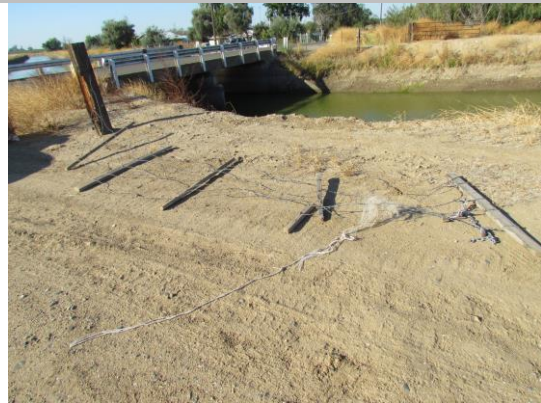
Photo 1 of 1 : FA_2015_NA0013_331_4_20151020_00003.jpg

LM Start	1.24	Rating **	M	Issue No.	4
LM End	1.24	Issue Type +	Ma	Location *	CR
Category	Earthen Levee			GPS Latitude/Longitude	
				Start	End
Item	Repair Gates			37.332165 °	37.332165 °
				-120.394698 °	-120.394698 °
DWR ID	DWR_NA0013_01_f_2014_4				
Action/Comments					
Inspector Comments: This wire gate across the crown roadway needs to be replaced.

This wire gate needs replacing, it poses a safety hazard.

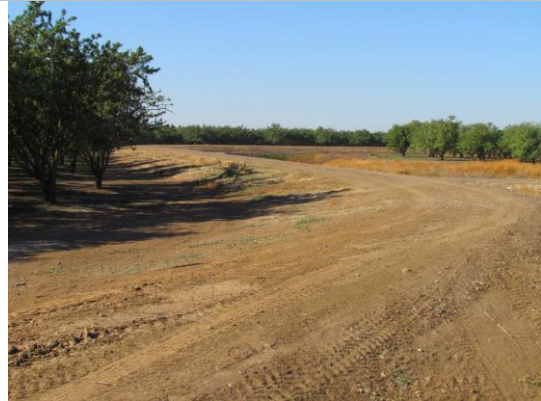
Photo 1 of 1 : FA_2015_NA0013_332_16_20151020_00014.jpg

LM Start	0.01	Rating **	A	Issue No.	16
LM End	0.67	Issue Type +	Ma	Location *	LS
Category	Earthen Levee			GPS Latitude/Longitude	
				Start	End
Item	Vegetation			37.337022 °	37.331307 °
				-120.387448 °	-120.394517 °
DWR ID	DWR_NA0013_02_f_2015_16				
Action/Comments					
Control annual grass and weeds on the levee slopes and easements. Inspector Comments: No unwanted vegetation on the landside levee slope.

Black Rascal Creek looking downstream from levee mile 0.01.

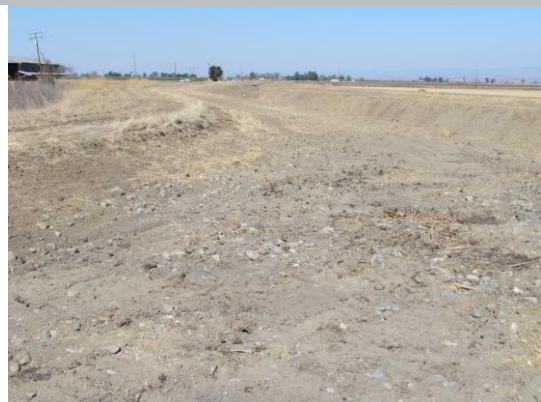
Photo 1 of 1 : FA_2015_NA0013_333_17_20151020_00013.jpg

LM Start	0.01	Rating **	A	Issue No.	17
LM End	1.41	Issue Type +	Ma	Location *	WS
Category	Earthen Levee			GPS Latitude/Longitude	
				Start	End
Item	Vegetation			37.257730 °	37.273627 °
				-120.288435 °	-120.277820 °
DWR ID	DWR_NA0013_03_f __ 2015_17				
Action/Comments					
Control annual grass and weeds on the levee slopes and easements. Inspector Comments: The Maintaining Agency has done a great job clearing the slope of unwanted vegetation.

Owens Creek looking downstream from levee mile 0.00 waterside slope.
